Barren Island Dredged Material Placement for Regional Sediment Management

by Robert N. Blama

PURPOSE. This Coastal and Hydraulics Engineering Technical Note (CHETN) describes activities that have occurred in the Chesapeake Bay to assist with Regional Sediment Management (RSM) activities by the US Army Corps of Engineers Baltimore District, Baltimore, MD. The Baltimore District employs the beneficial use of dredged material, specifically at Barren Island in the Chesapeake Bay, to prevent erosion of the remote island. This CHETN describes the beneficial use of dredged material at Barren Island. Finding a cost-effective, environmentally acceptable disposal site for the dredged materials is a challenge for all dredging projects, particularly for small navigational dredging projects. One such project is the Honga River and Tar Bay small navigation project in the Chesapeake Bay. An eroding barrier island that is protecting the mainland is located close to this Federal project. This technical note describes the use of geotextile tubes and dredged material to accomplish the Baltimore District's Operation and Maintenance (O&M) dredging mission for the Federal navigation project, while als

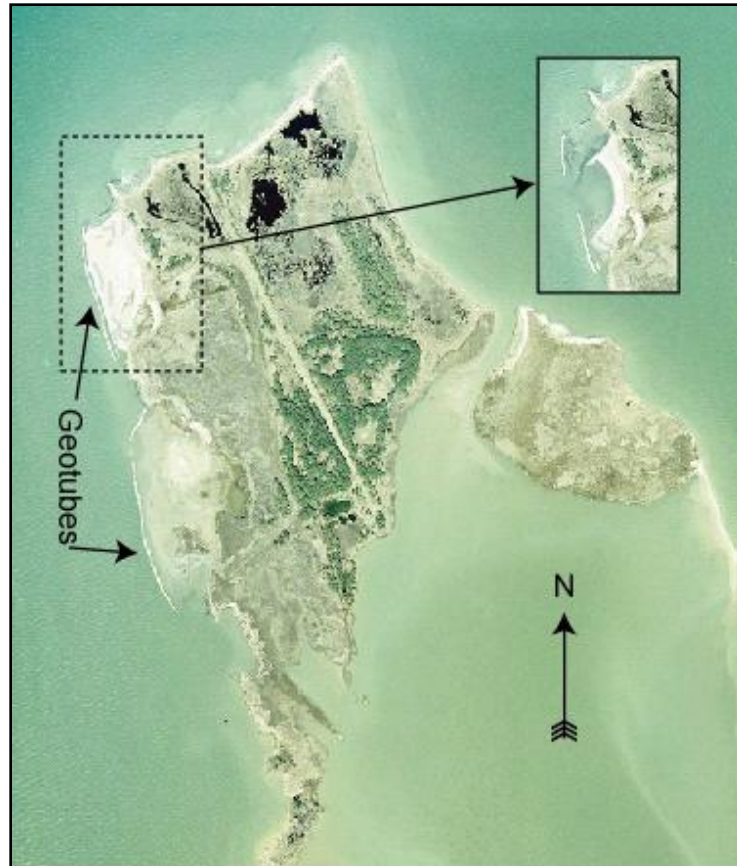
In 1994, a contract was awarded to allow filling and placing of geotextile tubes along the western side of Barren Island using material dredged from the Federal navigation channel (Figure 2). A medium-sized hydraulic dredge was used that had a 12-in. discharge pipe. The geotextile tubes were placed in the same area as the 1989 location, but in deeper water. The 4-ft contour was used as the line for all additional tubes. A series of geotextile bags were filled to obtain the required height. After installation of the bags, a dredging contract was awarded to pump the remaining material from the channel and place that material behind the geotextile bags. The initial tubes placed in 1989 that had failed were located within the 1994 site, and were covered with this dredged material. After the material was allowed to settle for approximately 1 month, the area was planted with *Spartina alterniflora* (smooth cordgrass) and *S. patens* (salt meadow cordgrass). Initial success occurred as the wetlands thrived. However, erosion of the wetland began to occur in areas where the geotextile bags failed.

Figure 2. Location of geotextile tubes on western side of Barren Island (photo 1994).

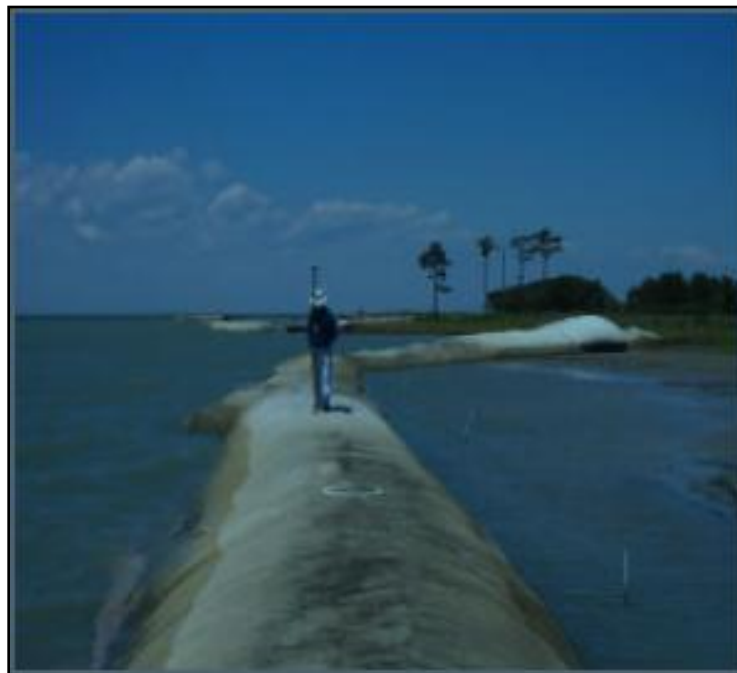
Coarse sand was purchased and brought to the site, and used to fill the geotextile bags (Figure 3). The bags were placed end-to-end to create an in-water confined placement site (Figure 4). Even though the bags were constructed according to specifications, the closure structure (snorkel or filling sleeve) could not be kept tied and, when wave action caused this filling sleeve to open, sand was lost and re-suspended once again in the tube. Once more, wetlands species were planted on the dredged material and thrived (Figure 5), but some of the geotubes lost height, which caused wetlands in those areas to erode.

Figure 3. Geotextile tubes fully inflated, before placing dredged material, western side of Barren Island (photo 2000).

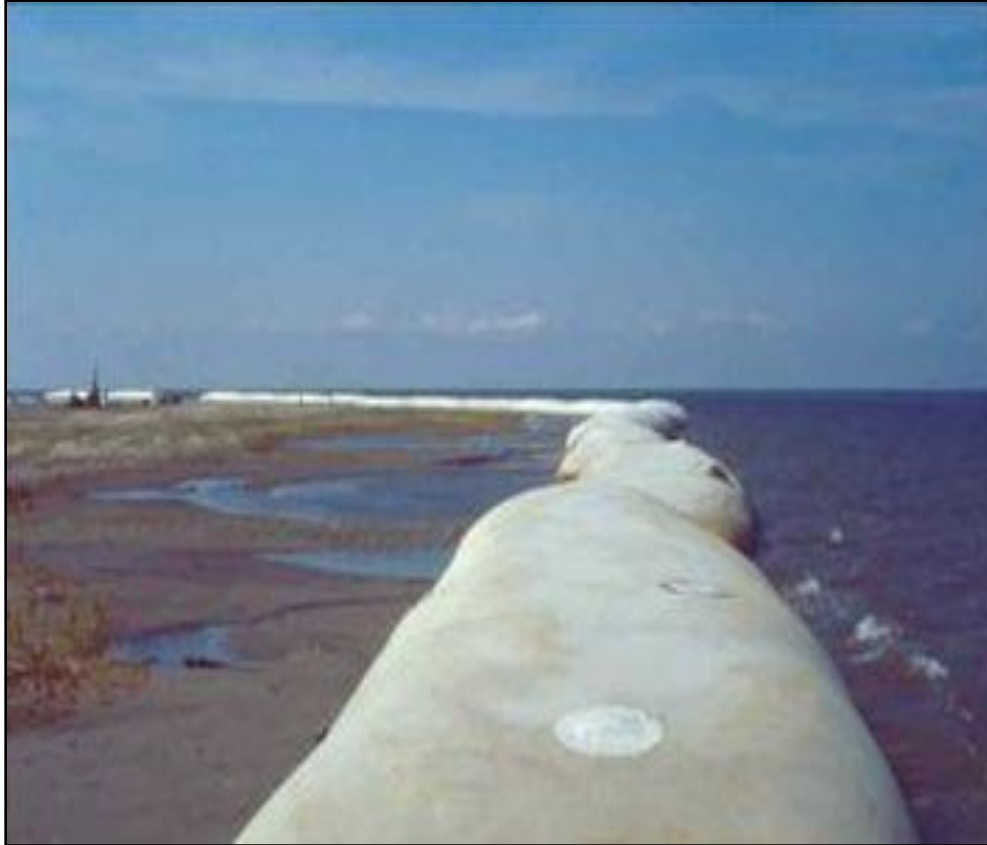
Figure 4. Geotextile tubes after dredged material had been placed behind them, western side of Barren Island (photo 2000).

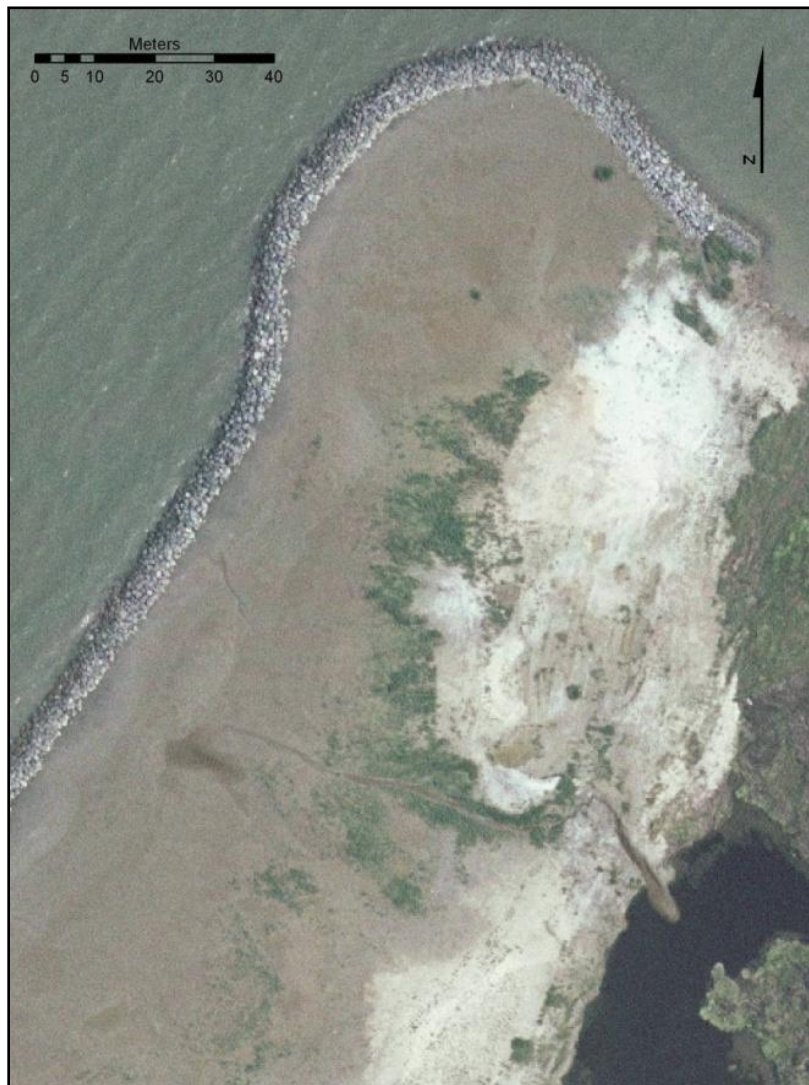
The northern end of Barren Island had been experiencing heavy erosion and was subjected to some of the worse winds to hit the island. This area did not have any geotextile tubes placed there. The 4-ft contour was again used as the line for placement, and a continuous offshore rock breakwater was constructed in 2003 until it reached some of the surviving geotextile tubes on the western side. Rock was applied to and beyond the area where geotubes were working (Figure 6). Rock was placed anywhere there were gaps in the tubes, and at the end of the tubes. The rock structure was constructed to a height of +2.5 ft above mean lower low water (mllw) with some notches created in the breakwater at a +2.0 ft above mllw to allow for tidal flushing and species ingress and egress. Dredged material placed inside this structure was planted with *Spartina* and *Juncus* (rushes) (Figures 7 and 8). This area has been very successful, and wetlands were established and still thriving with no subsequent loss of the dredged material (Figure 9). Additionally, other features were created within the marsh area. In the area where the pipeline was discharging, a bowl or kettle was formed in the placement site and allowed to stay. When this area was inundated by the tide, a tidal pond was created, which is now used by various aquatic species.

Figure 6. Northern end of Barren Island where stone breakwater was constructed in 2003, dredged material was placed, and planted with *Spartina* (photo August 2005).

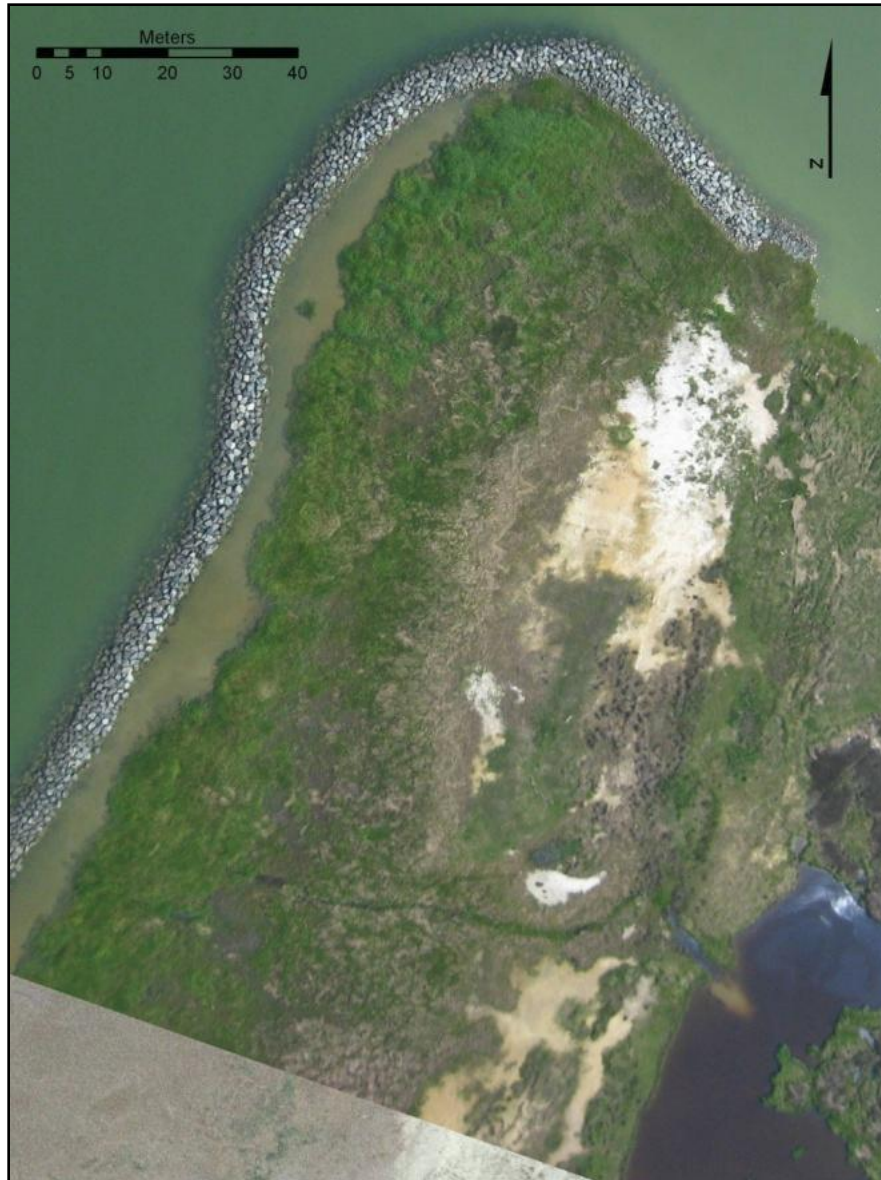
Figure 9. *Spartina* growth on dredged material placed behind stone breakwater on northern end of Barren Island in August 2008, 3 years after planting.
